REPORT OF APOLLO 204 REVIEW BOARD

**APPENDIX D
PANEL 5**

**REPORT OF PANEL 5
ORIGIN AND PROPAGATION OF FIRE
APPENDIX D-5
TO
FINAL REPORT OF
APOLLO 204 REVIEW BOARD**

ORIGIN AND PROPAGATION OF FIRE

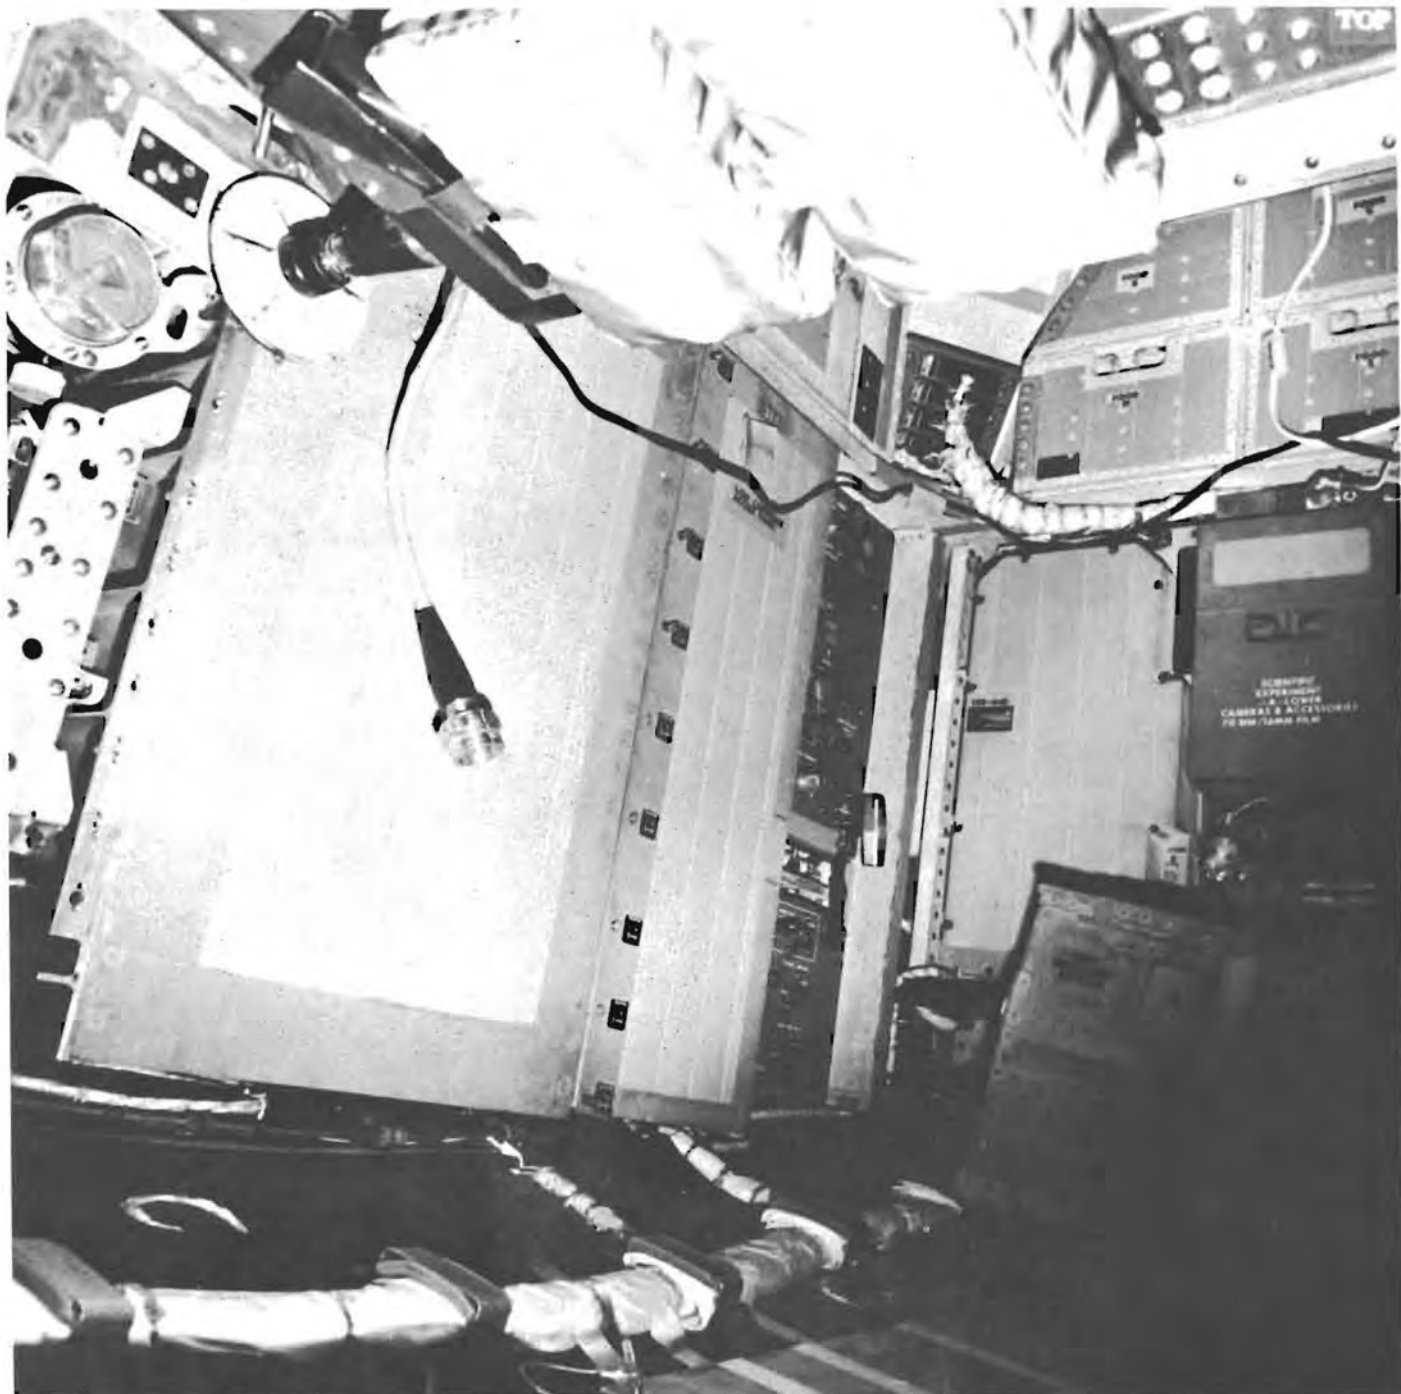
ENCLOSURE 5-2

f. One example of wire insulation damage that may have preceded the fire is illustrated by photograph (Enclosure 5-2). The circled area in the figure shows a wire bundle which lies over a bare stainless steel tube that is a waste management line. This tube lies below the aluminum access door to the carbon dioxide and odor absorber compartment of the Environmental Control Unit (ECU). When the door was opened and closed, its lower edge may have chafed the wires of this bundle. There was no chafing guard for the Teflon insulation on these wires; this made them vulnerable to damage. Teflon is particularly vulnerable to cold flow and mechanical damage. Wire splices close by increased the susceptibility of the insulation to chafing damage. Careful investigation showed that the splices were too far from the chafing point to matter. Combustibles in the form of polyurethane foam and nylon netting lay close to the electrical arcs and sparks that would occur if the Teflon insulation were defeated. The same wires damaged by fire are shown encircled in photograph (Enclosure 5-3).

WIRING UNDER CO₂ ABSORBER ACCESS DOOR

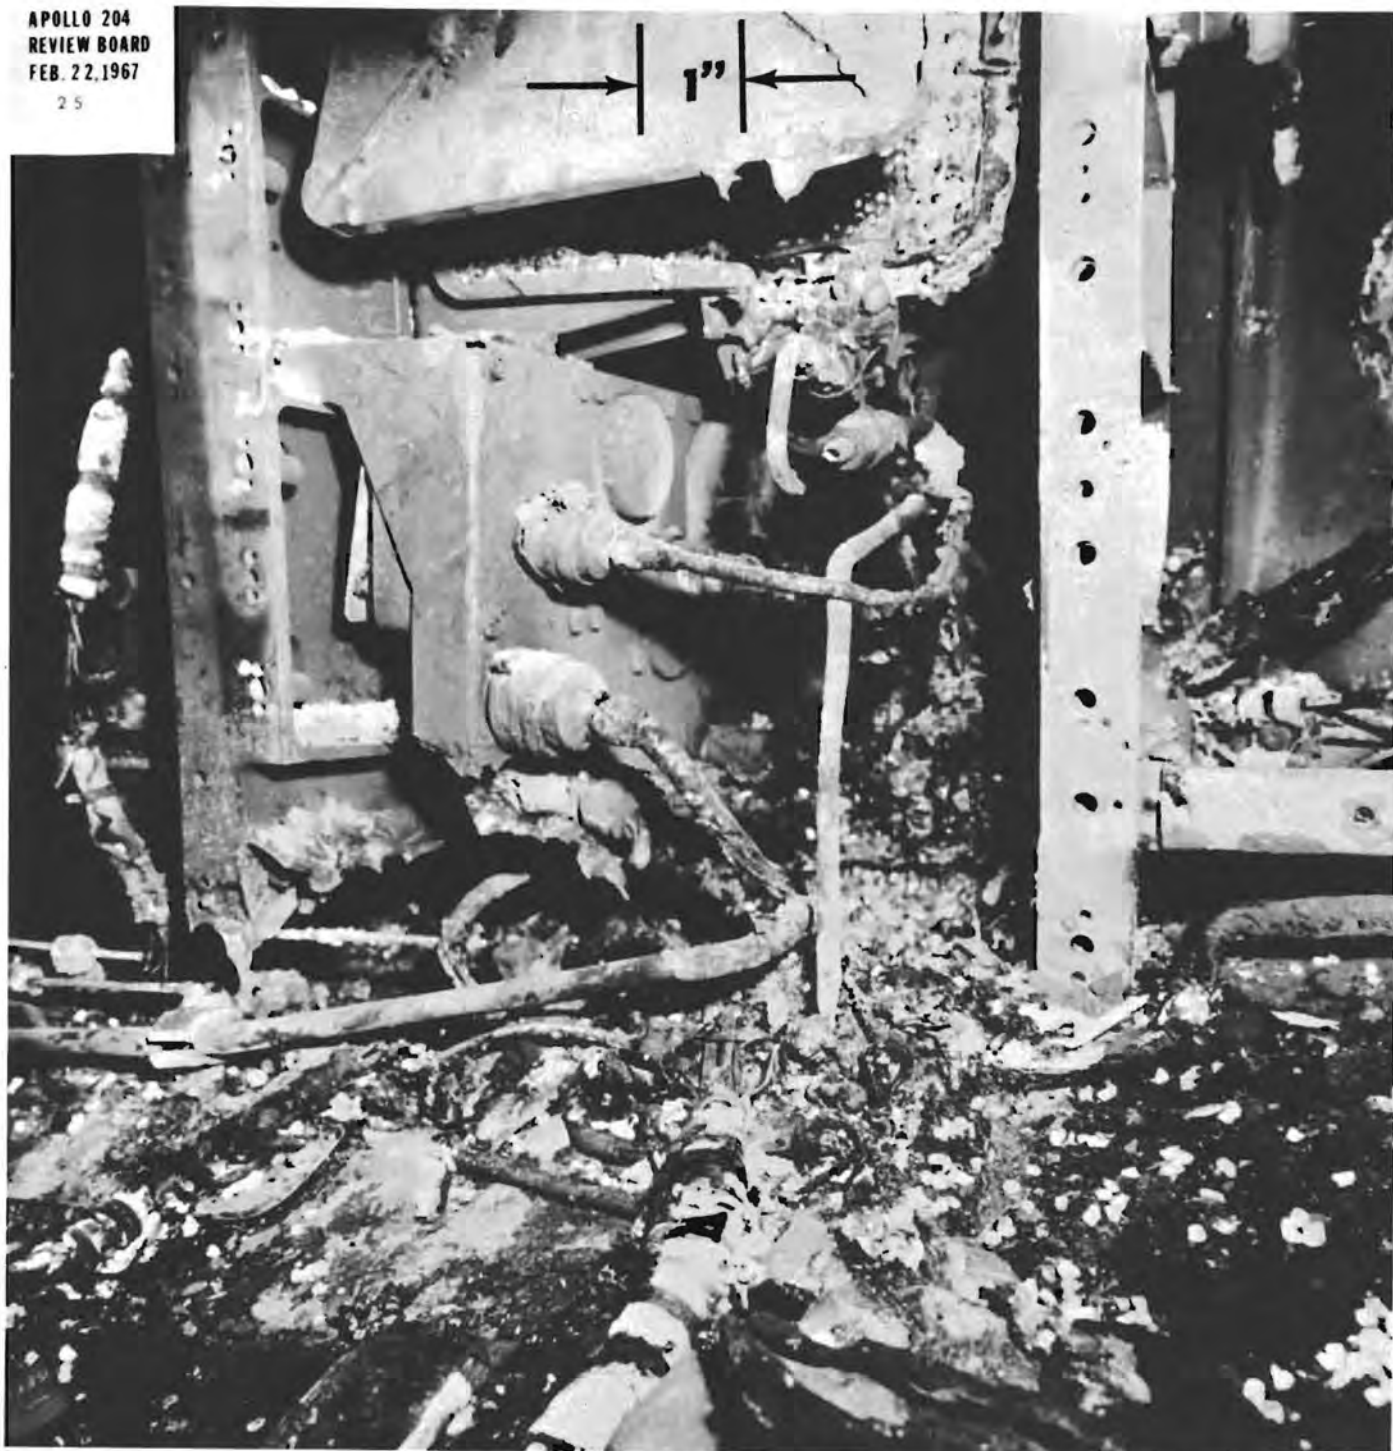
DAMAGED WIRING UNDER ACCESS DOOR

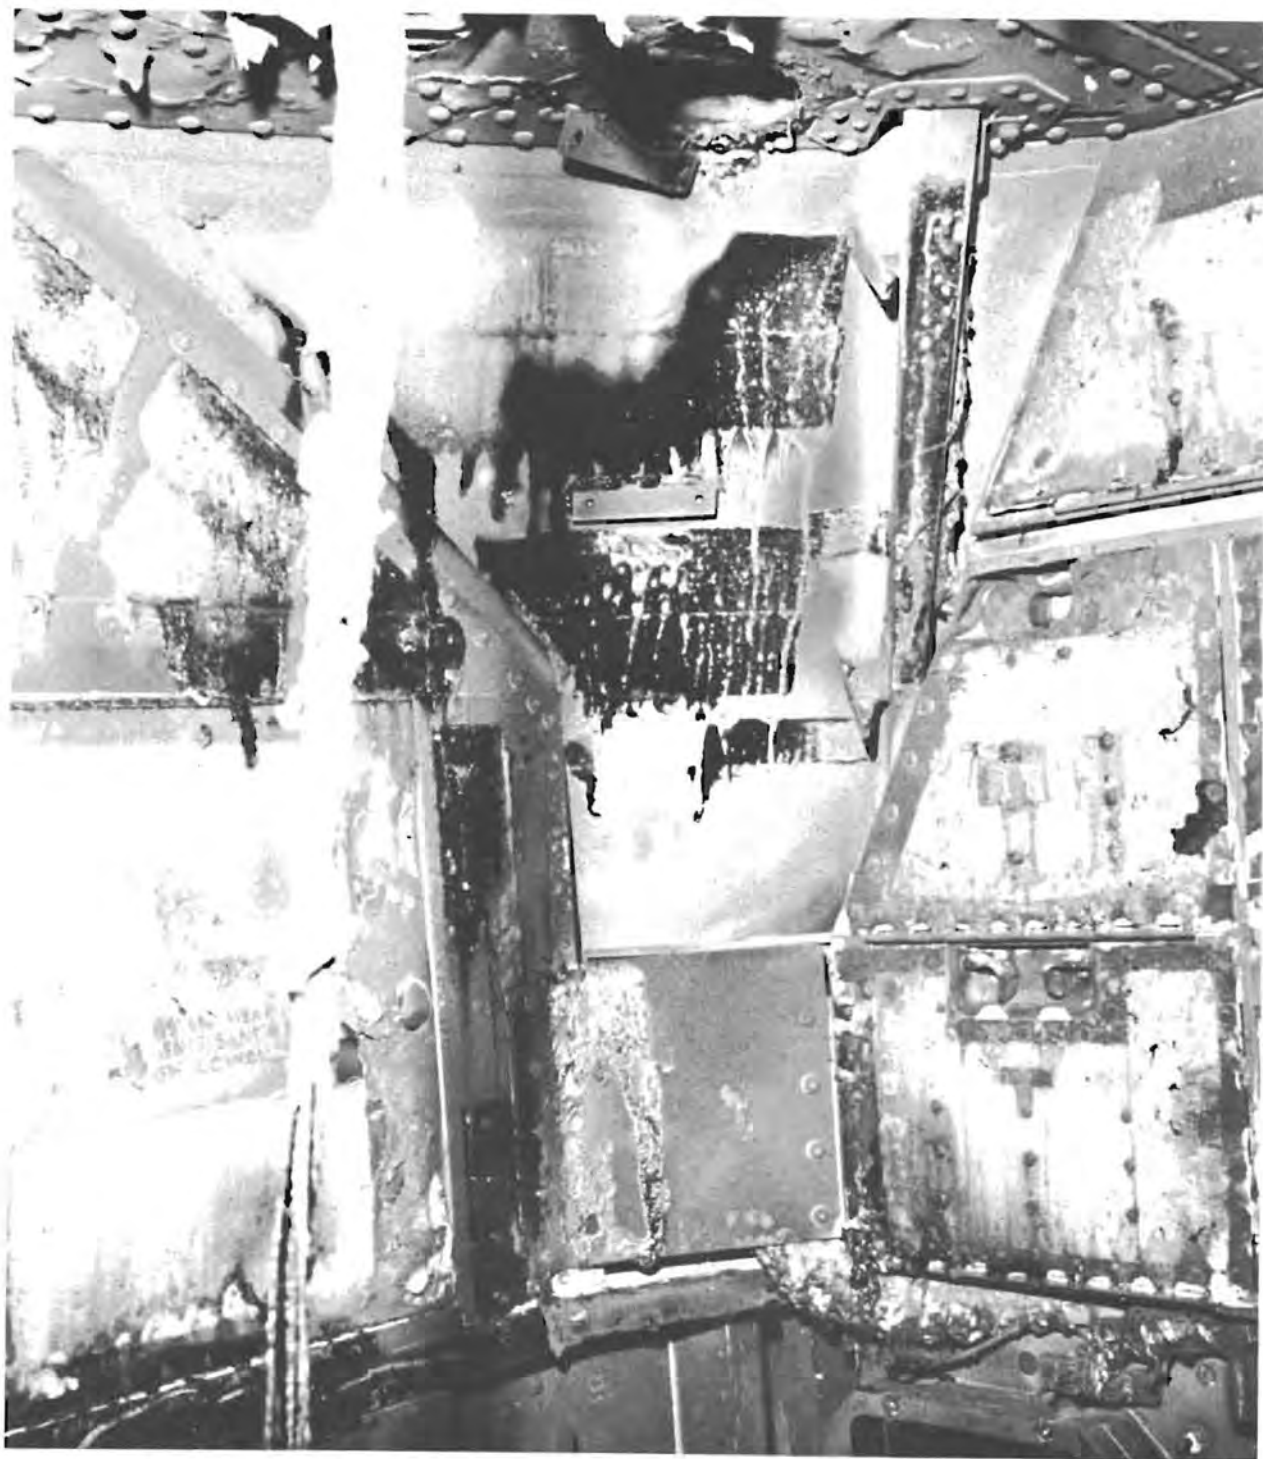
ENCLOSURE 5-10

EXTREME UPPER LEFT HAND CORNER BETWEEN LOWER EQUIPMENT BAY
AND LEFT HAND EQUIPMENT BAY

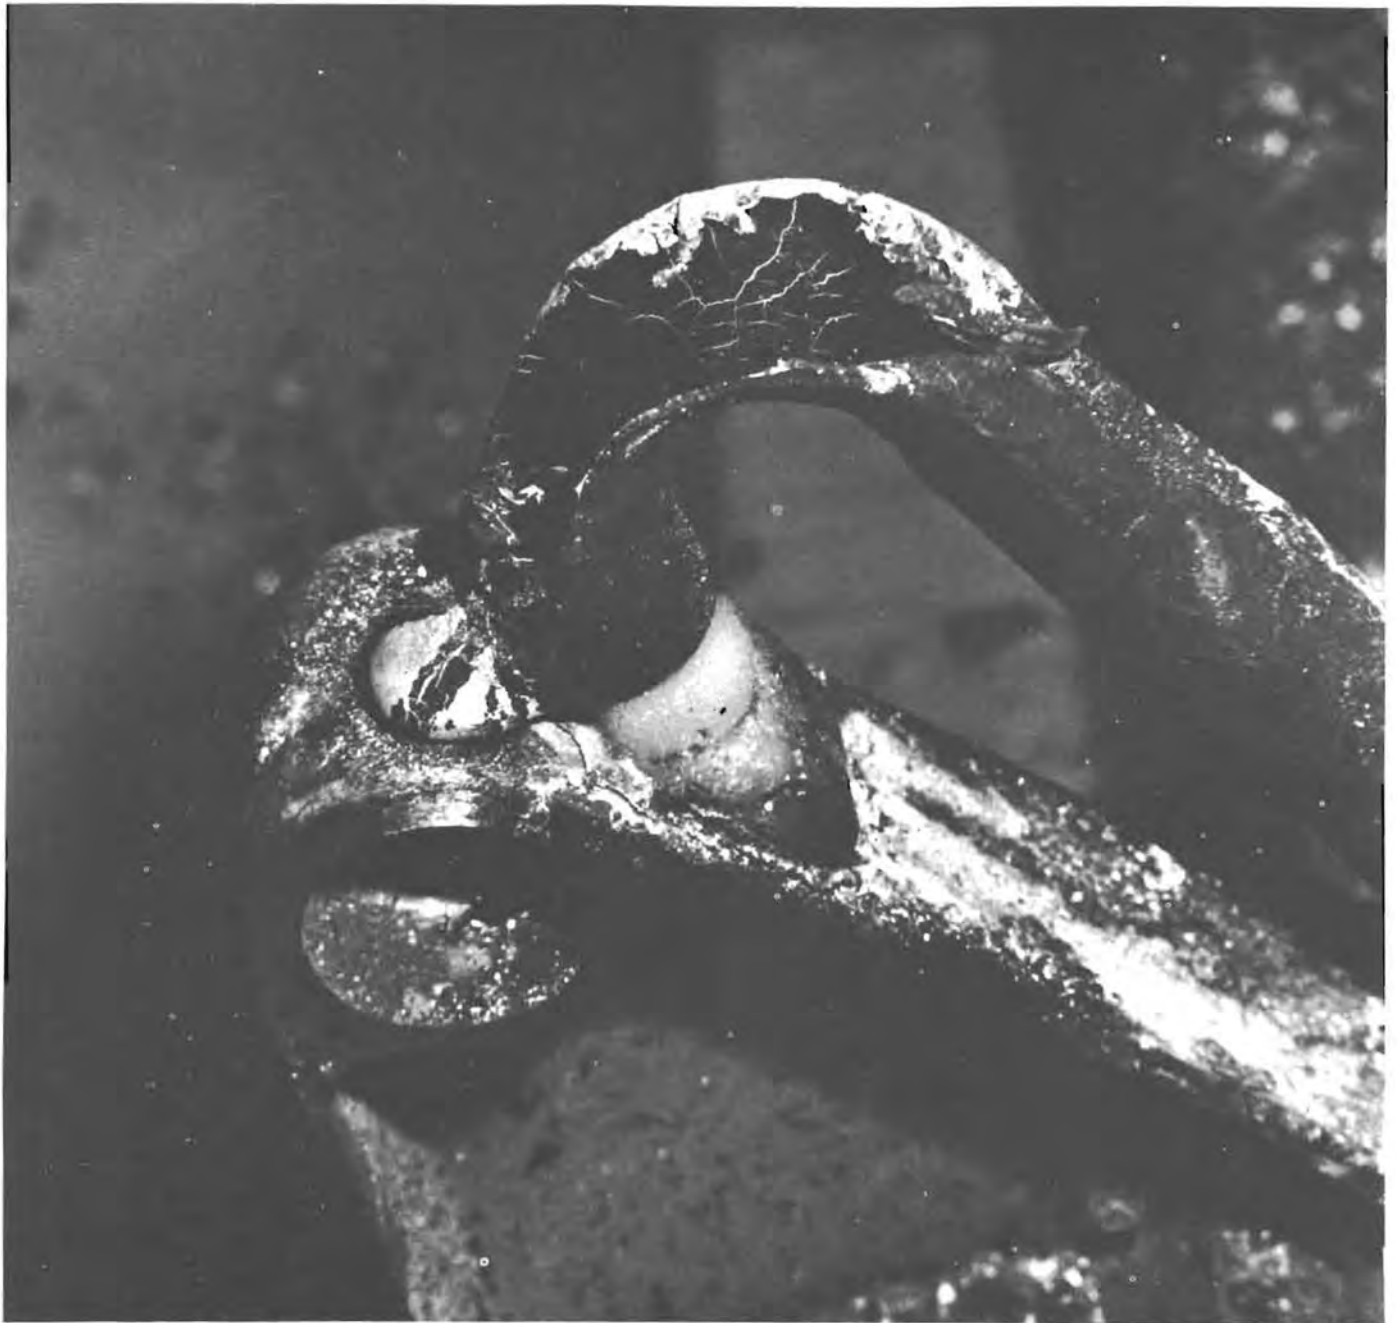
ENCLOSURE 5-14

i. Further evidence that fire crossed the couches from left to right is given by the melting and burning of the leg rest control handle on the left side of the left couch. This handle is formed from aluminum tubing. Tongues of flame flowing over the handle melted and burned its left side where heat transfer would be greatest. The result was a softened and deformed ledge of aluminum on the right side where the heat transfer was less (Enclosure 5-14). A plastic button at the base of the handle shows little deformation and no burning. An aluminum ingot deposited by molten metal from the handle lies adjacent to the plastic button.

LEG REST CONTROL HANDLE

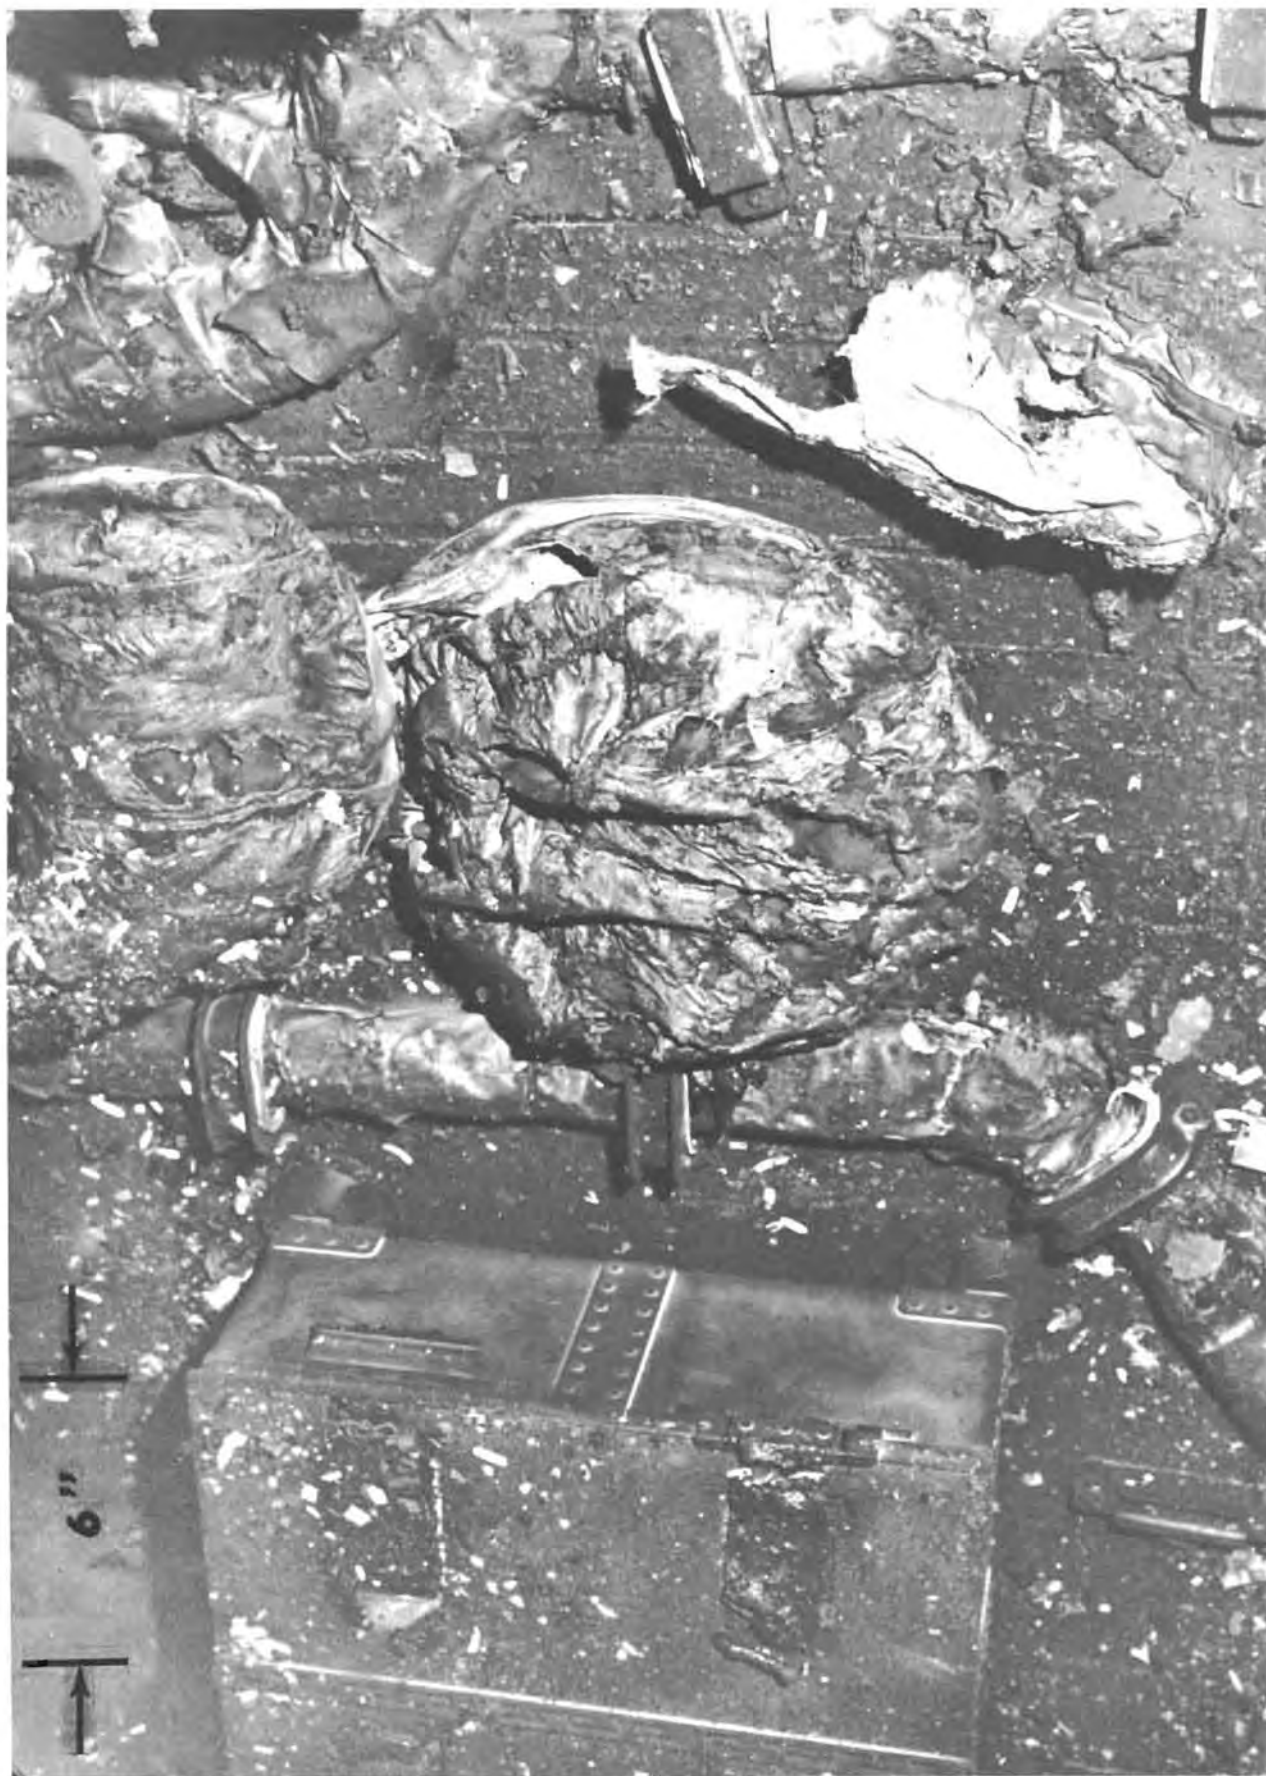
j. Some of the fire below the couch also swept in the direction of the floor break (Enclosure 5-15). Fire damage to the three helmet covers lying on the floor below the Senior Pilot's (middle) couch indicated that some of this flame spread around the lithium hydroxide (LiOH) canister storage box to the left of the helmet covers (Enclosure 5-16). Fire damage to these covers is greatest on their left sides where the flames impinged. The fire damage to the helmet covers, shown in this photograph, is consistent with this view of the path taken by the flames at this location. Enclosure 5-17 is a view of the helmet cover which lies closest to the hatch. Because the camera faces the hatch, the left side of the C/M is on the viewer's right.

VIEW OF HELMET COVERS

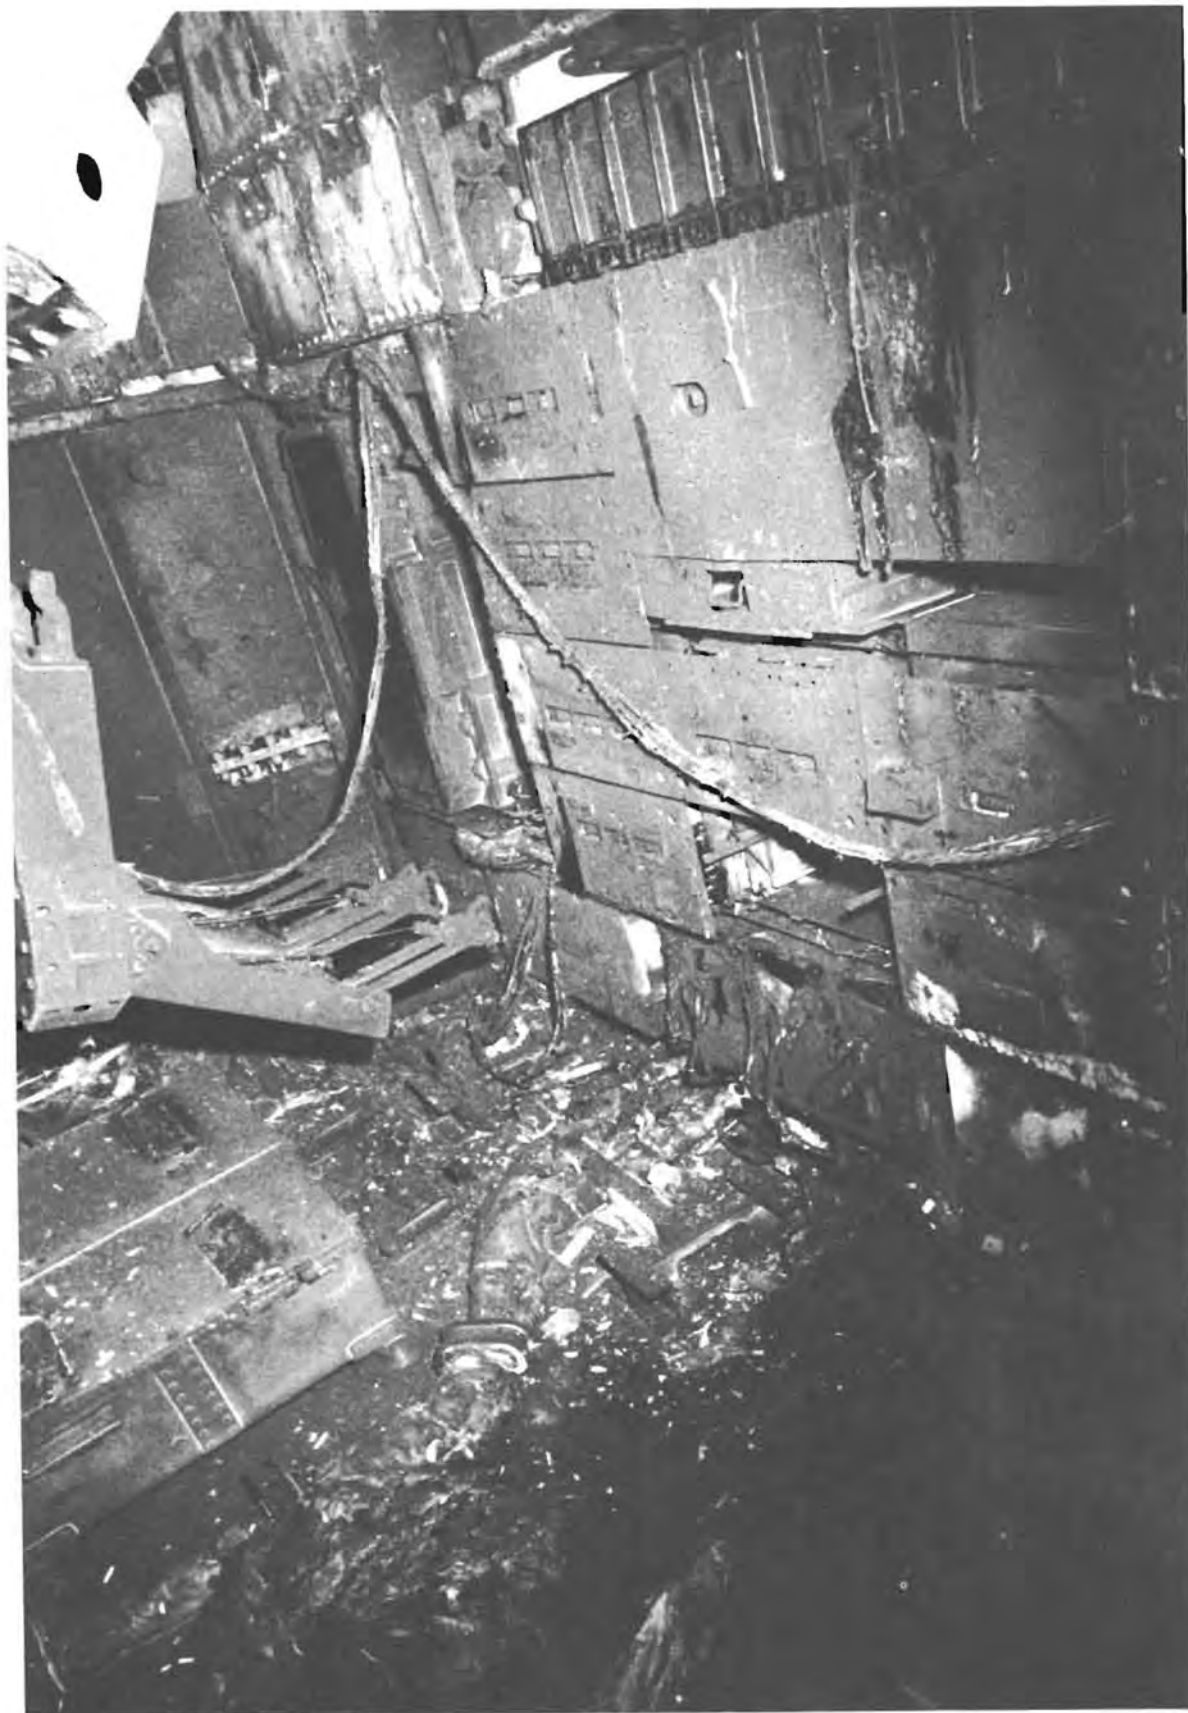
ENCLOSURE 5-18

l. Flames also moved from left to right along the front panel at slightly above floor level. With reference to Enclosures 5-18 and 5-19, which show a portion of the floor in front of this panel, the damage to wire bundles where fire impinged is shown to be greater than to those which lie to their right, as indicated by the arrows on the photograph. The same relative fire damage is apparent on the metal clamp covering the wire bundles, being greatest on the left and least at the right.

VIEW OF FLOOR BELOW LOWER EQUIPMENT BAY

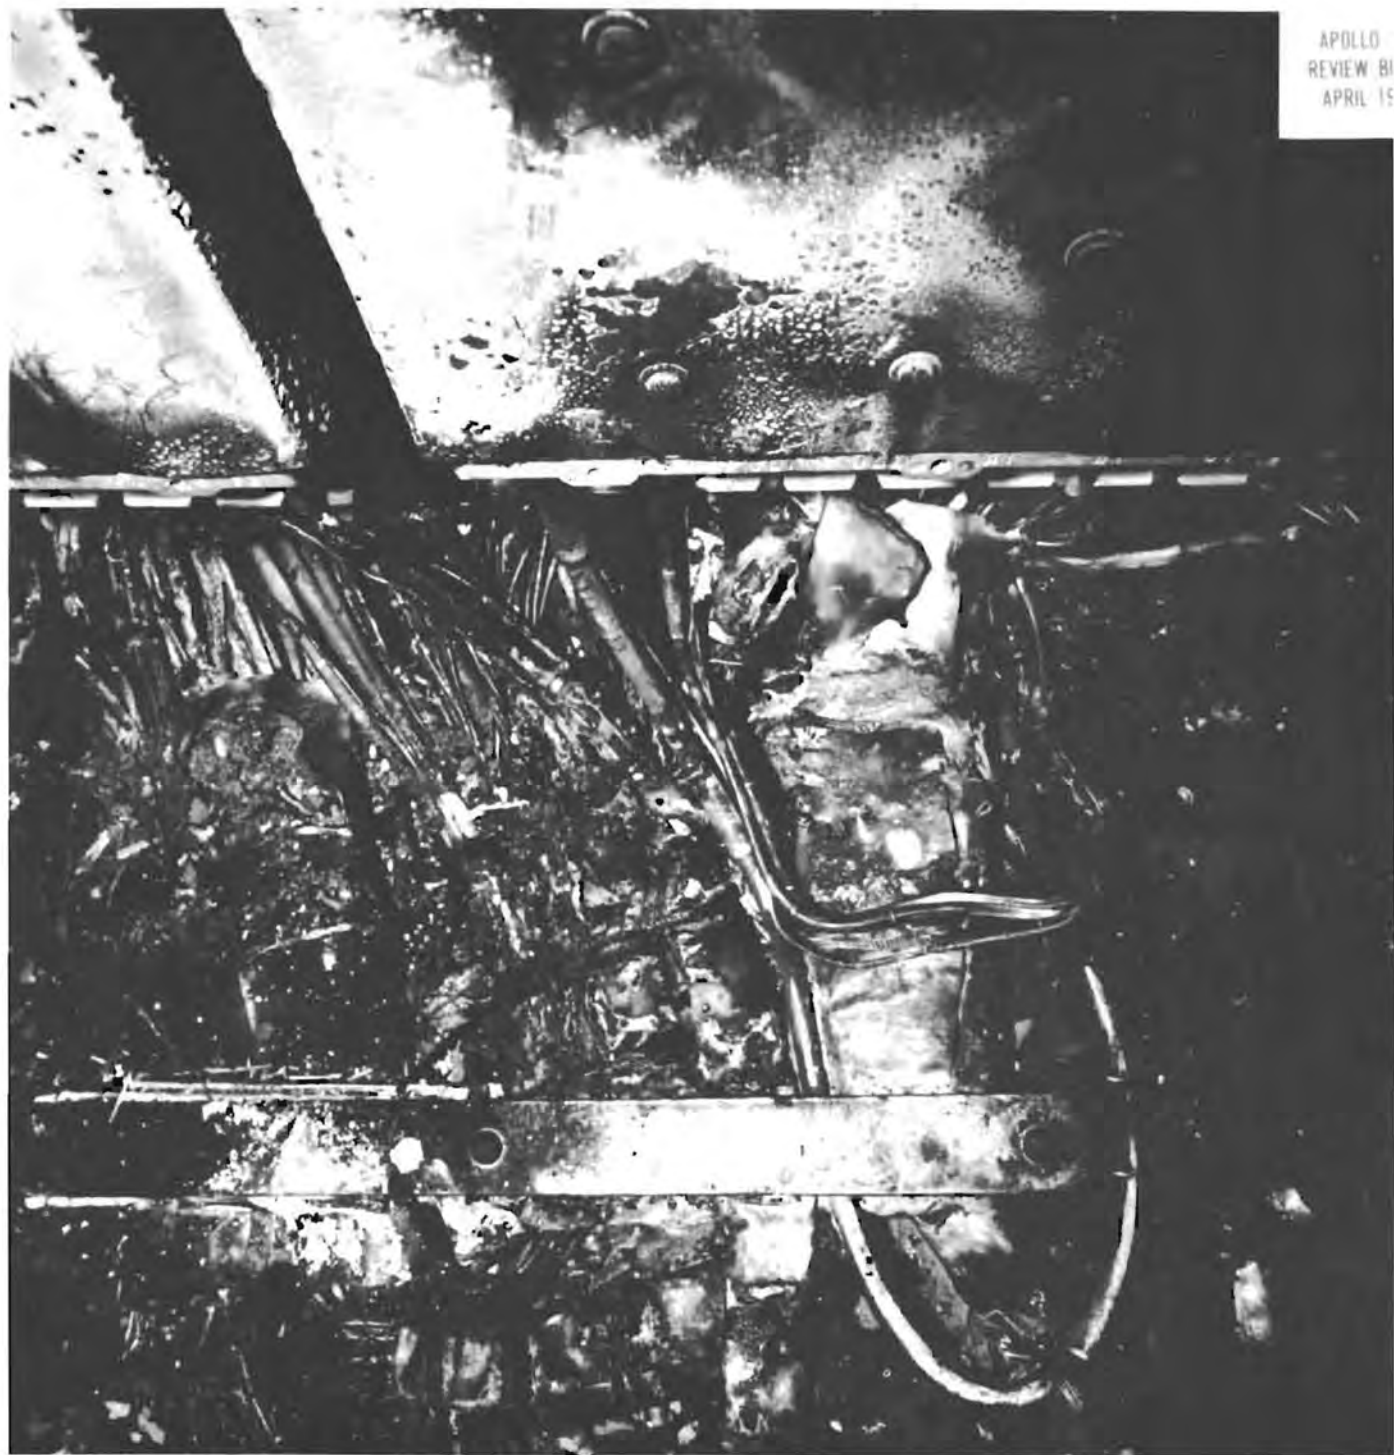
VIEW OF AFT BULKHEAD WIRING BELOW INVERTERS

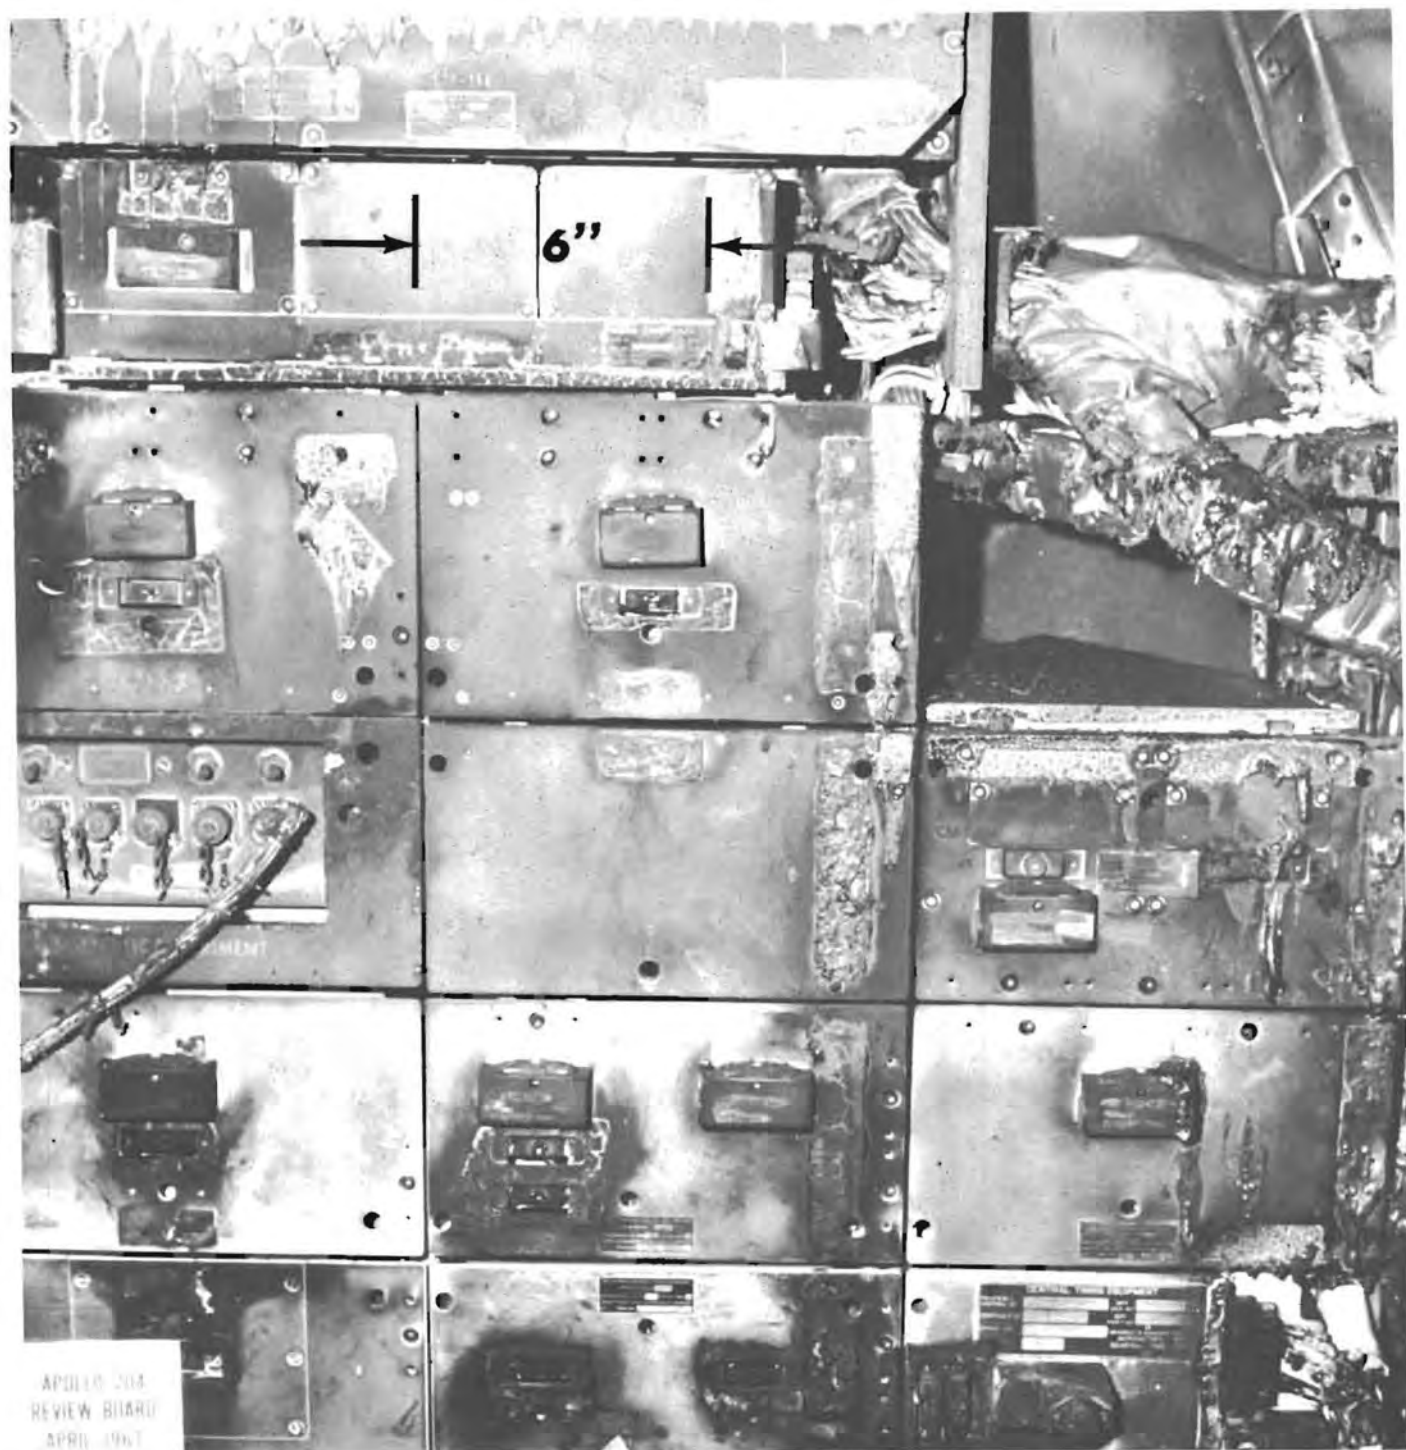
m. Substantial fire damage to paint and wiring insulation appears along the front panel, particularly above the batteries, and inverters as shown in Enclosure 5-20.

INSTRUMENTATION ABOVE INVERTERS

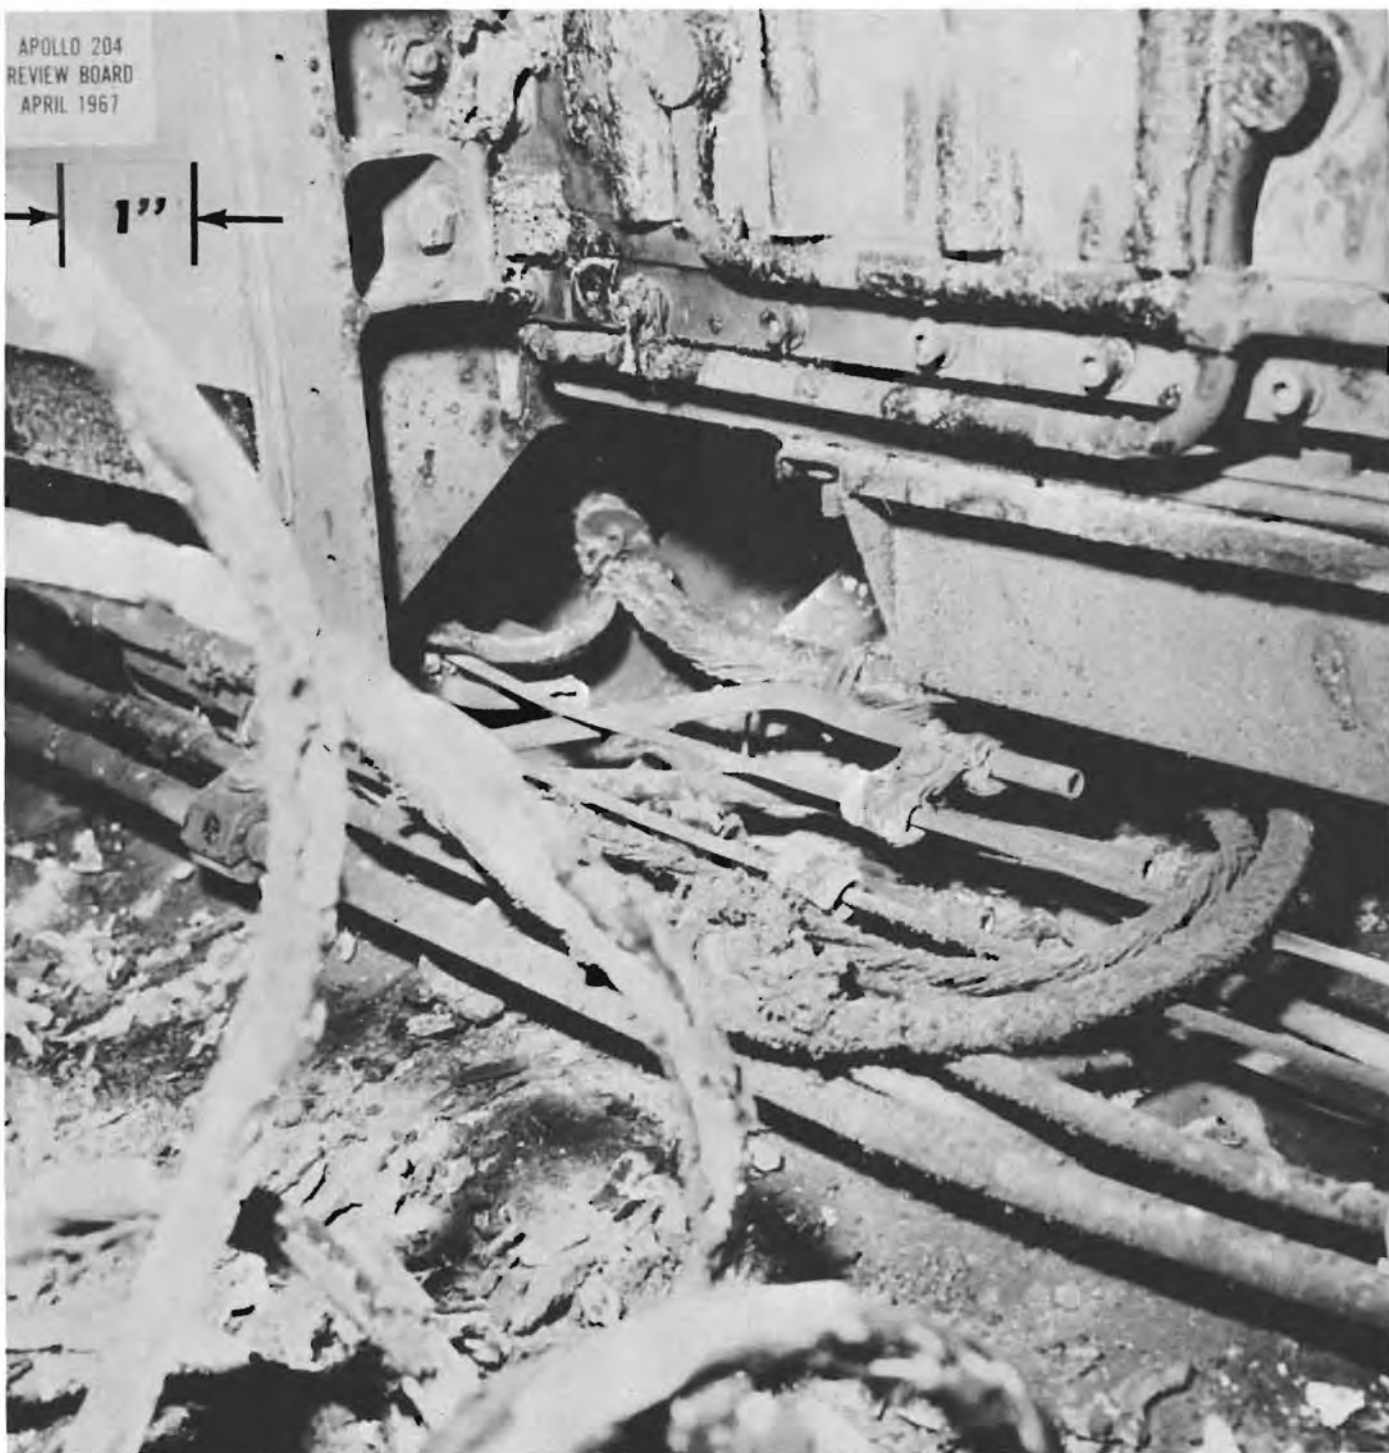
p. Some of the failed 100 and 900 psia oxygen tubing below the Environmental Control Unit are shown in Enclosure 5-21. This photograph shows separated solder joints and burst aluminum tubing running near floor level below the suit circuit heat exchanger. The adjacent portion of the ECU, which contains the LiOH canisters shown in Enclosure 5-3, revealed broken coolant tubing (upper circle), more failed oxygen lines in the oxygen control panel area, and holes burned through the aft bulkhead and pressure vessel wall. The container for the LiOH canisters and adjacent structure show severe damage from a hot, sustained fire.

TUBING BELOW ENVIRONMENTAL CONTROL UNIT HEATING EXCHANGER

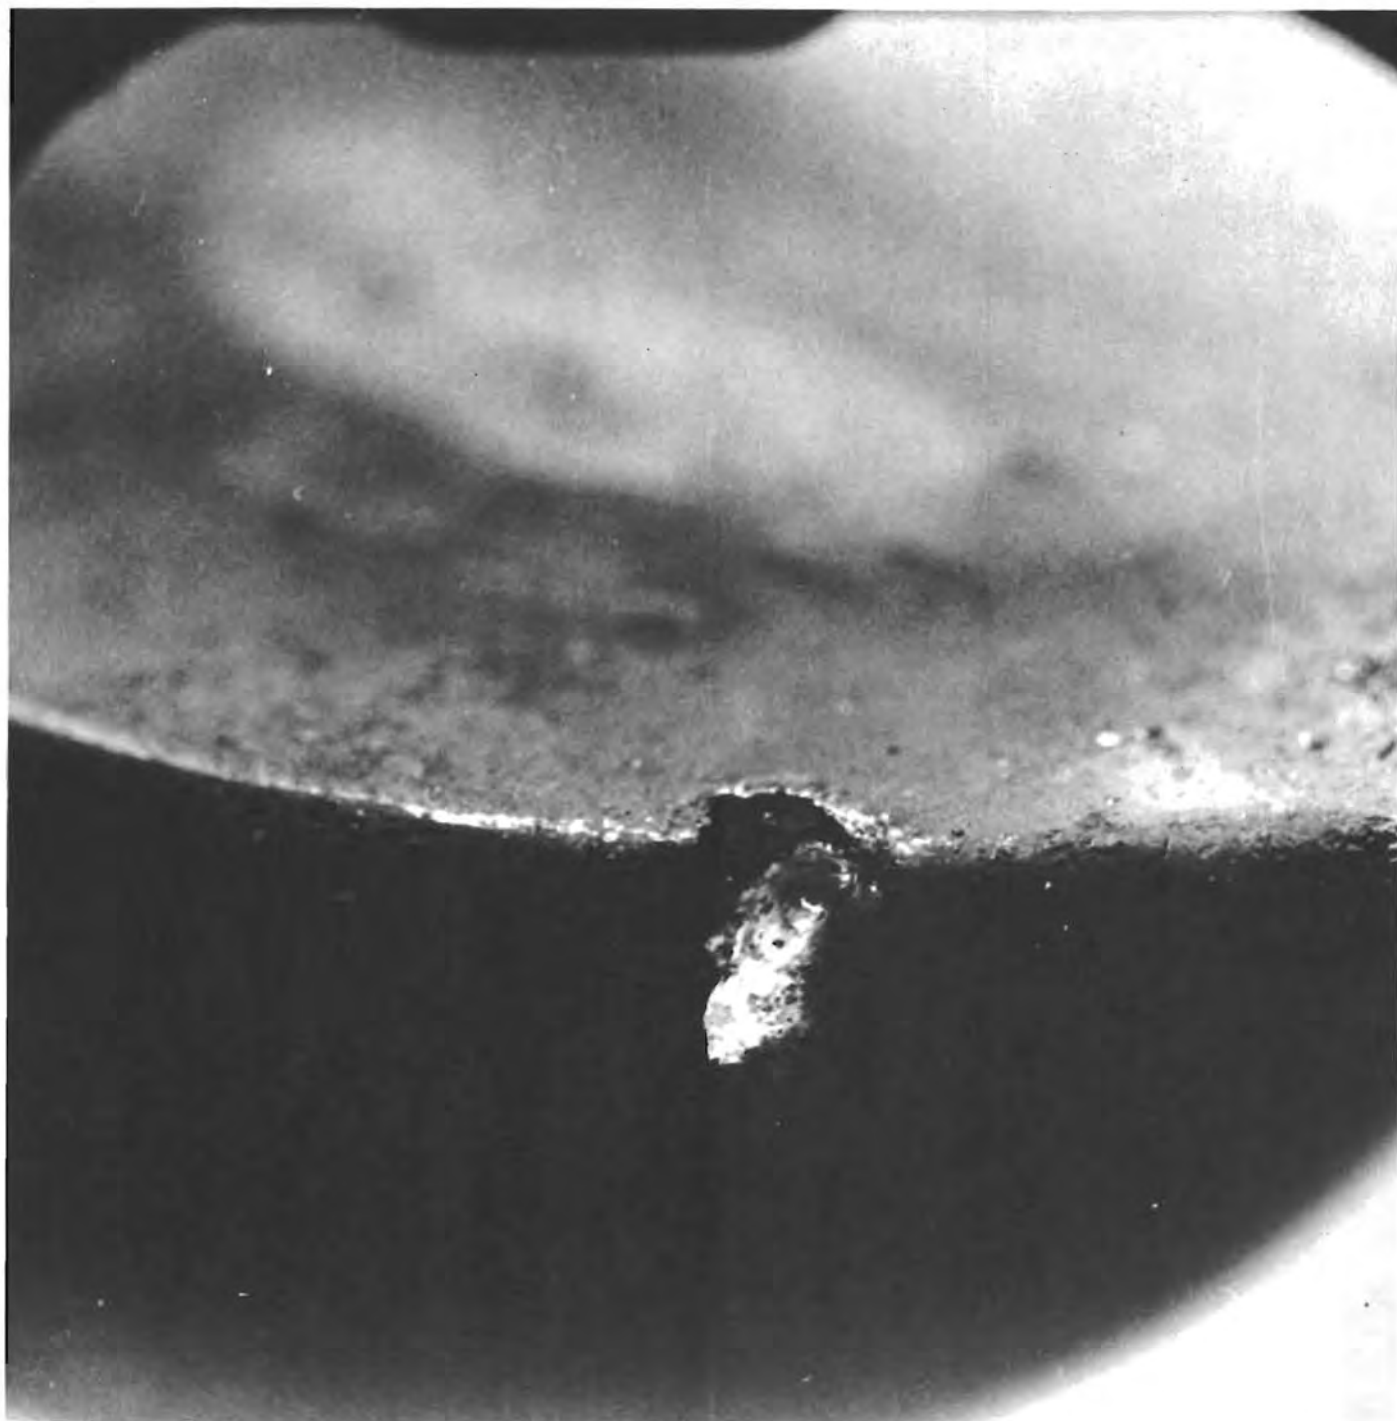
ENCLOSURE 5-31A

VIEW OF ARC ON PANEL 109
